# 4-Point Inspection Form

Actual Year Built: 2016 Date Inspected: 9/20/2022

HI 9087  
 License Number

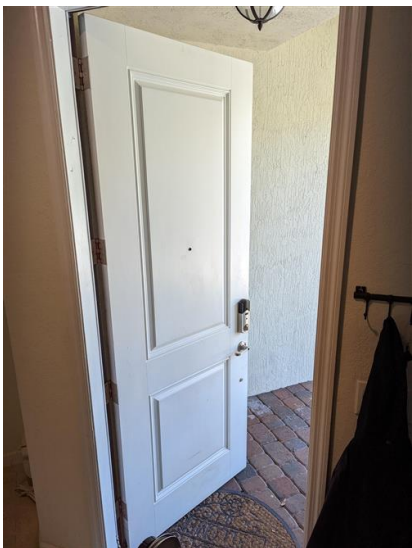
Front Door (Appears A1 - No documentation)

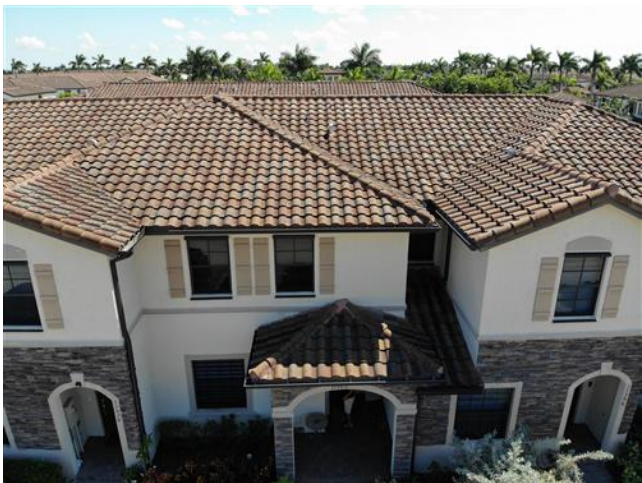
Roof Covering

Covering material: Concrete Tile

- ☒ Satisfactory  
☐ Unsatisfactory (**explain below**)

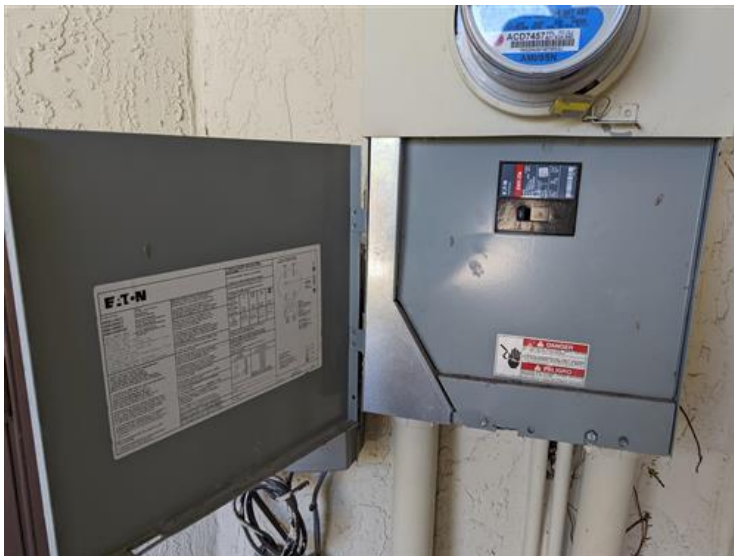
Main Panel

Brand/Model: EATON

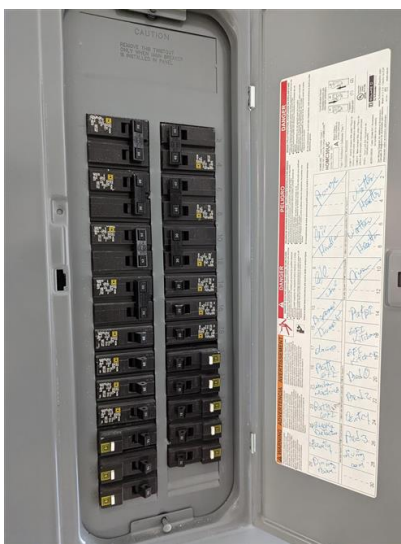
Secondary Panel

Brand/Model: Square D

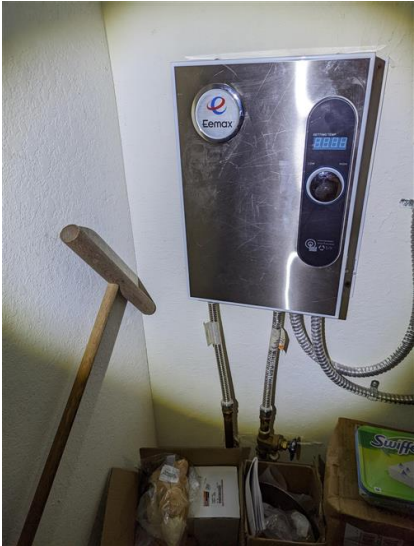
Water Heater

Tankless Water Heater, MFD: 2016
