# Uniform Mitigation Verification Inspection Form

| Inspection Date: 12/8/2022 | | |

Inspectors Initials DT Property Address 6437 NW 171st St, Hialeah, FL 33015

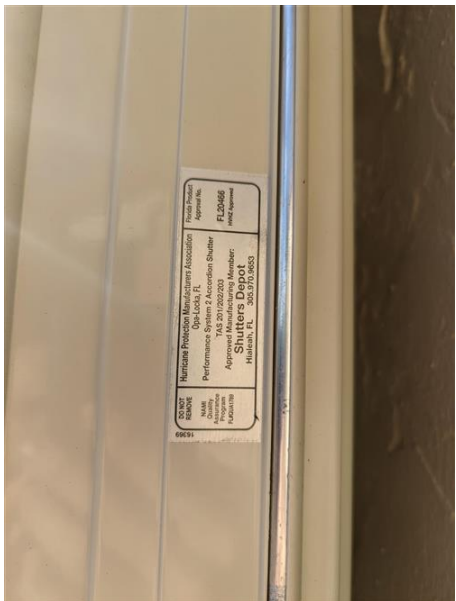
- ☒ **A. Exterior Openings Cyclic Pressure and 9-lb Large Missile (4.5 lb for skylights only)** All Glazed openings are protected at a minimum, with impact resistant coverings or products listed as wind borne debris protection devices in the product approval system of the State of Florida or Miami-Dade County and meet the requirements of one of the following for "Cyclic Pressure and Large Missile Impact" (Level A in the table above).

Shutter Label

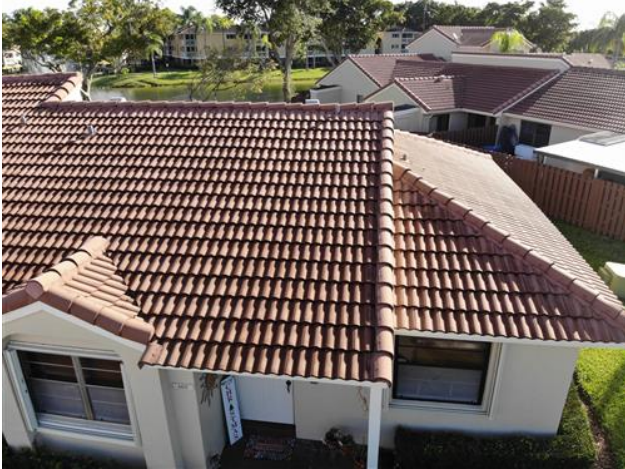
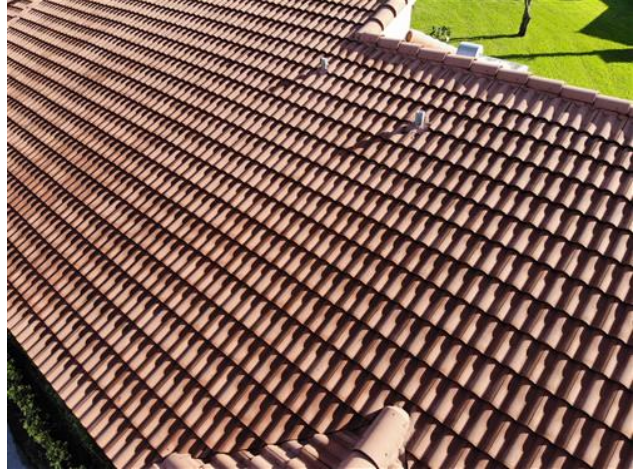
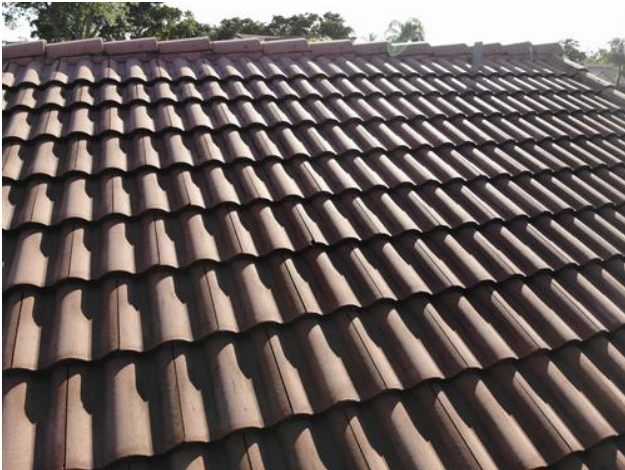
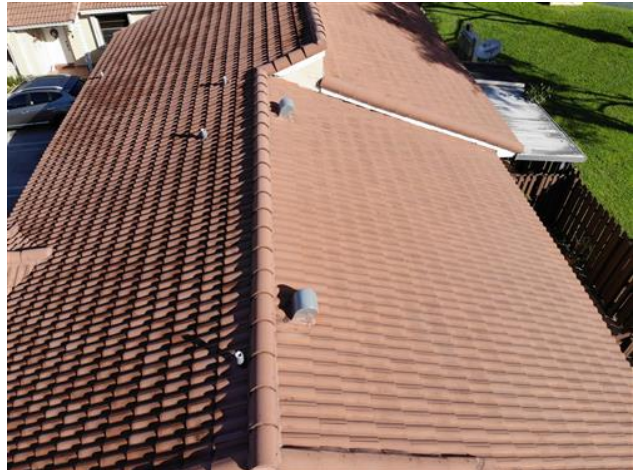
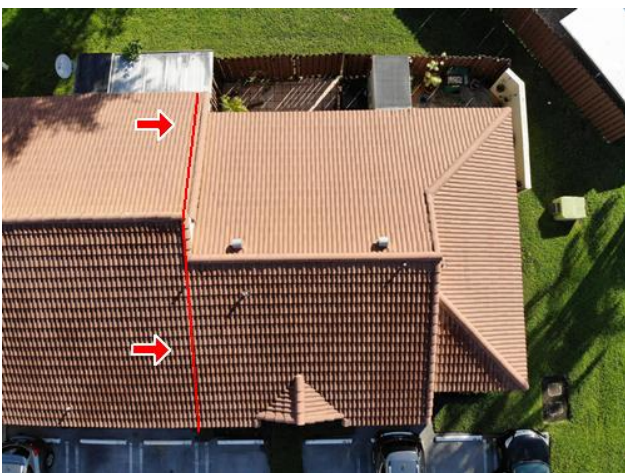
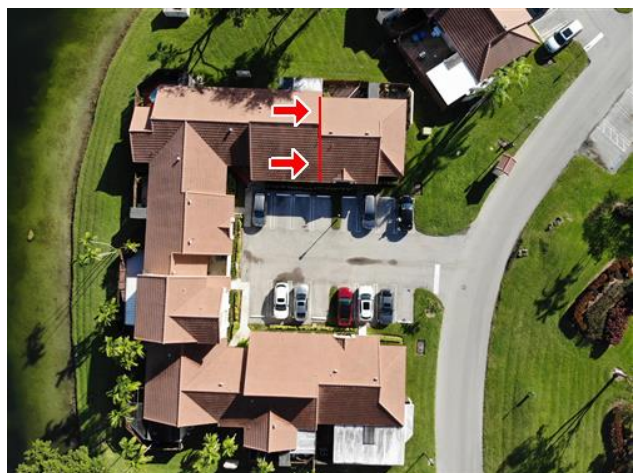
| 2.1 Roof Covering Type: | Permit Application Date | FBC or MDC Product Approval # | Year of Original Installation or Replacement | No Information Provided for Compliance |
|---|---|---|---|---|
| <input checked="" type="checkbox"/> 2. Concrete/Clay Tile | 01/19/2016 | 2016019553 | 2016 | <input type="checkbox"/> |

- ☒ A. All roof coverings listed above meet the FBC with a FBC or Miami-Dade Product Approval listing current at time of installation OR have a roofing permit application date on or after 3/1/02 OR the roof is original and built in 2004 or later.

Roof Covering

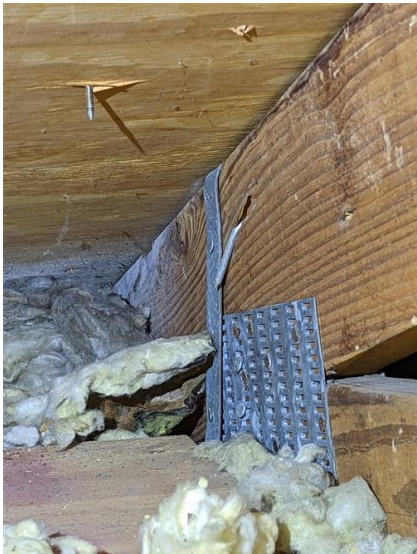
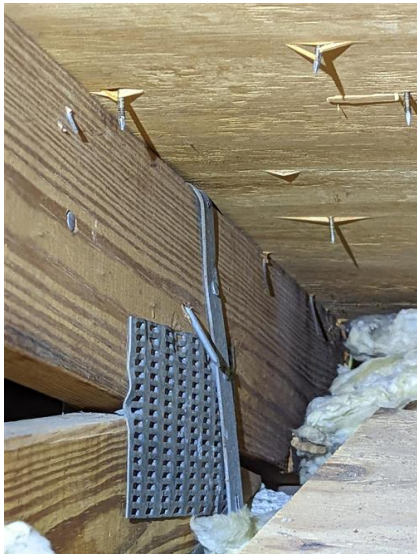
- ☒ Secured to truss/rafter with a minimum of three (3) nails, **and**
- ☒ Attached to the wall top plate of the wall framing, or embedded in the bond beam, with less than a ½" gap from the blocking or truss/rafter **and** blocked no more than 1.5" of the truss/rafter, **and** free of visible severe corrosion.

- ☒ C. Single Wraps
  - Metal connectors consisting of a single strap that wraps over the top of the truss/rafter and is secured with a minimum of 2 nails on the front side and a minimum of 1 nail on the opposing side.

Wall to Roof Connection

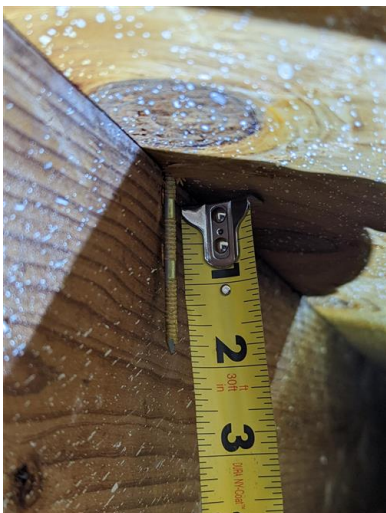
- ☒ C. Plywood/OSB roof sheathing with a minimum thickness of 7/16" inch attached to the roof truss/rafter (spaced a maximum of 24" inches o.c.) by 8d common nails spaced a maximum of 6" inches in the field. -OR- Dimensional lumber/Tongue & Groove decking with a minimum of 2 nails per board (or 1 nail per board if each board is equal to or less than 6 inches in width). -OR- Any system of screws, nails, adhesives, other deck fastening system or truss/rafter spacing that is shown to have an equivalent

8D Fasteners

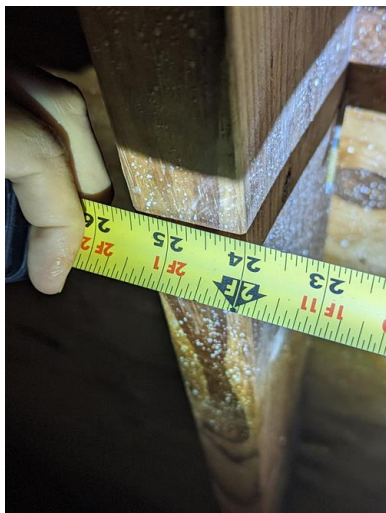
Rafter distance - 24" OC

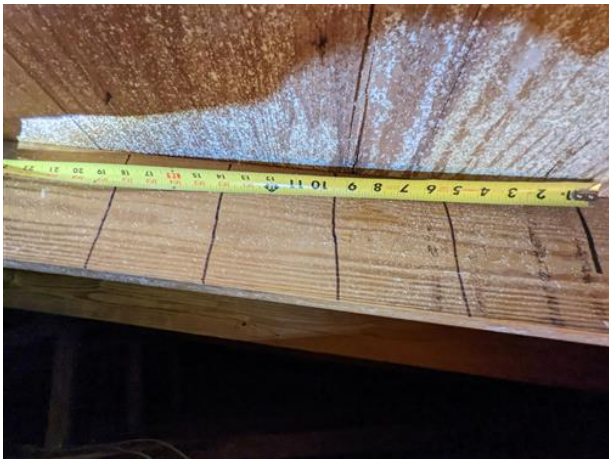
Rafter nail distance

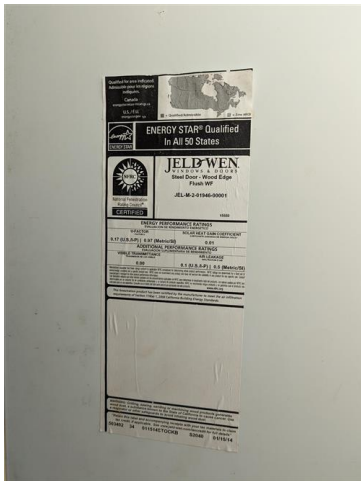
- Southern Standards Technical Document (SSTD) 12
  - For Skylights Only: ASTM E 1886 and ASTM E 1996
  - For Garage Doors Only: ANSI/DASMA 115
- ☒ A.1 All Non-Glazed openings classified as A in the table above, or no Non-Glazed openings exist

Non-glazed door impact label
